New Hampshire Volunteer Lake Assessment Program

2003 Biennial Report for Todd Lake Newbury

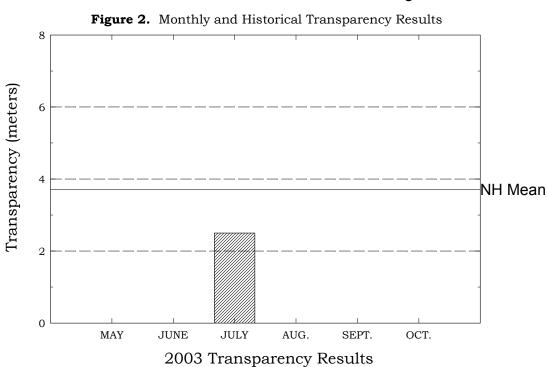
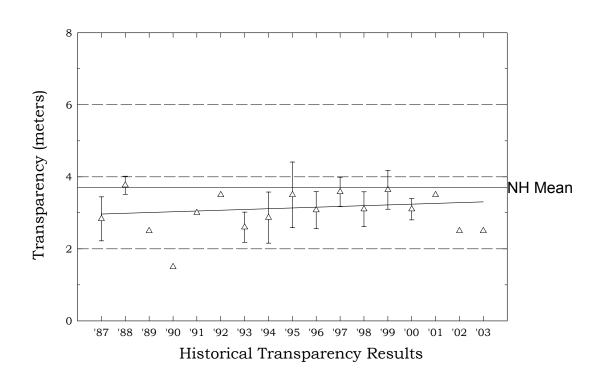
Figure 2 and Table 3: The graphs in Figure 2 (Appendix A) show historical and current year data for lake transparency. Table 3 (Appendix B) lists the maximum, minimum and mean transparency

The current year data (the top graph) show that the in-lake transparency in July was *less than* the state mean.

The historical data (the bottom graph) show that the 2003 mean transparency is *less than* the state mean.

Overall, the statistical analysis of the historical data (the bottom graph) show that the mean annual in-lake transparency has **not significantly changed** (neither *increased* nor *decreased*) since monitoring began in **1987**. Specifically, the in-lake transparency has remained **relatively stable** and has been **approximately equal to** the state mean. (Note: Please refer to Appendix E for the statistical analysis explanation and data print out.)

Typically, high intensity rainfall causes erosion of sediments into lakes/ponds and streams, thus decreasing clarity. Efforts should continually be made to stabilize stream banks, lake shorelines, disturbed soils within the watershed, and especially dirt roads located immediately adjacent to the edge of tributaries and the lake. Guides to Best Management Practices designed to reduce, and possibly even eliminate, nonpoint source pollutants, such as sediment loading, are available from DES upon request.

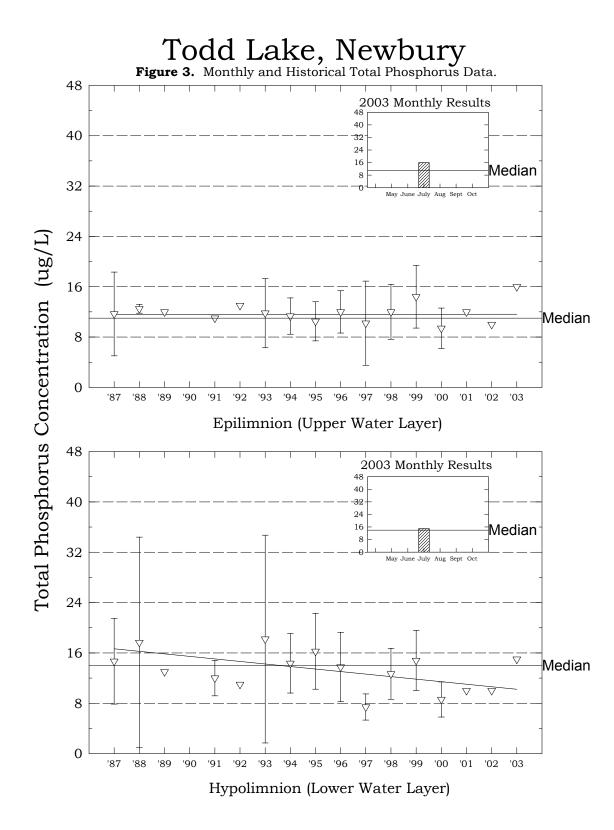
Figure 3 and Table 8: The graphs in Figure 3 (Appendix A) show the amounts of phosphorus in the epilimnion (the upper layer) and the hypolimnion (the lower layer); the inset graphs show current year data. Table 8 (Appendix B) lists the annual maximum, minimum, and median concentration for each deep spot layer and each tributary since the lake has joined the program.

The current year data for the epilimnion (the top inset graph) show that the phosphorus concentration in July was **greater than** the state median.

The historical data show that the 2003 mean epilimnetic phosphorus concentration is *greater than* the state median.

The current year data for the hypolimnion (the bottom inset graph) show that the phosphorus concentration in July was **approximately equal to** the state median.

The historical data show that the 2003 mean hypolimnetic phosphorus concentration is **approximately equal to** the state median.

Overall, the statistical analysis of the historical data show that the phosphorus concentration in the epilimnion (upper layer) and the hypolimnion (lower layer) has **not significantly changed** (neither increased nor decreased) since monitoring began in **1987**. Specifically, the phosphorus concentration in the epilimnion and hypolimnion has remained **relatively stable** and has been **approximately equal to** the state median. (Note: Please refer to Appendix E for the statistical analysis explanation and data print out.)

One of the most important approaches to reducing phosphorus loading to a waterbody is to continually educate watershed residents about its sources and how excessive amounts can adversely impact the ecology and value of lakes and ponds. Phosphorus sources within a lake or pond's watershed typically include septic systems, animal waste, lawn fertilizer, road and construction erosion, and natural wetlands.
